Prepared by Tandy Easler, Consultant
For the Town of Limestone, Maine
Under EPA 319-grant funding
Summer 2002

Examples of Typical Problems Identified in Survey

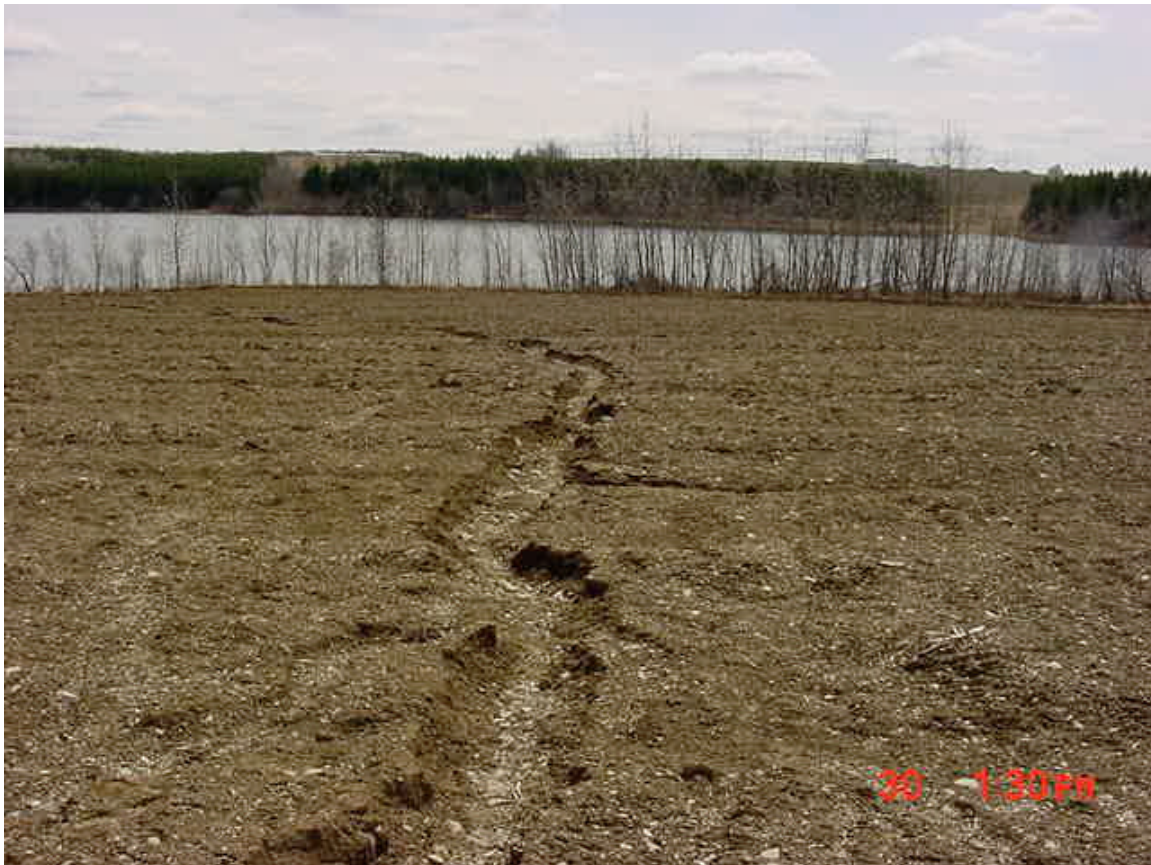
Problem: The gully here exhibits moderate soil erosion that is transported downhill to Trafton Lake. There was no winter cover planted to hold the soil in place and there is no buffer to intercept any soil or nutrients feeding the lake.

Solution: Plant a winter cover to keep vegetation on the soil through the spring thaw. Utilize conservation tillage to help reduce erosion. Fix drainage problems uphill. This particular site needs many terraces rebuilt above it to combat the movement of the soil. Furthermore, a vegetative buffer needs to be placed as a last line of defense. It would hold the shoreline together and intercept any nutrients washing downhill.

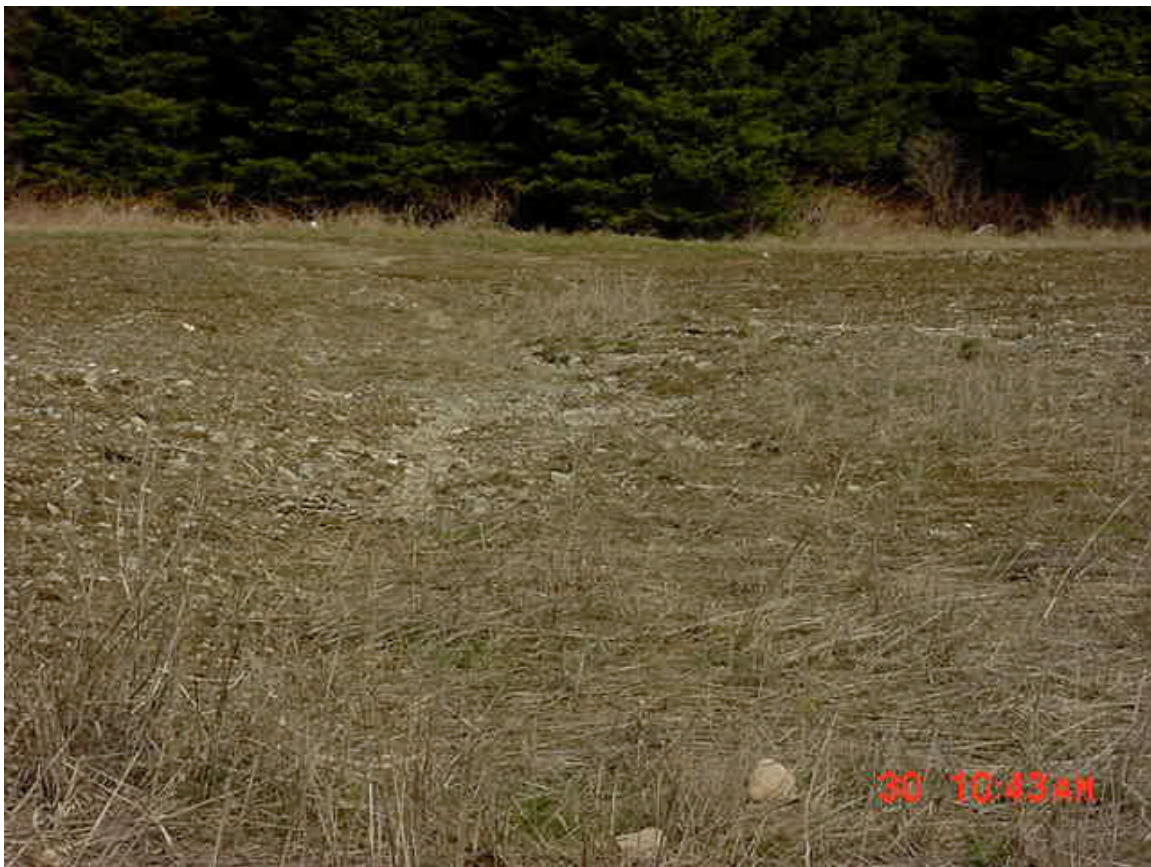
Problem: The problem in the following picture is a grassed waterway that lacks any depth. Waterways are typically built in the depressions of the land where most surface erosion occurs. These vegetated areas act as channels for water to flow. This grassed waterway is no longer doing its job. Water instead, is re-routing along the waterway's edges and eroding the sides where no vegetation exists.

Solution: Rebuild grassed waterway with proper depths, shape and armor to handle water velocities. Maintain a dense and vigorous vegetative growth in waterway and mow on an annual basis. Work-up any bare spots and re-seed as needed. If necessary, at the end of the ten-year life expectancy, contact your local NRCS office for further technical assistance. The soil saved in these grassed waterways can be removed and deposited back on the field where it can be used again to grow crops.

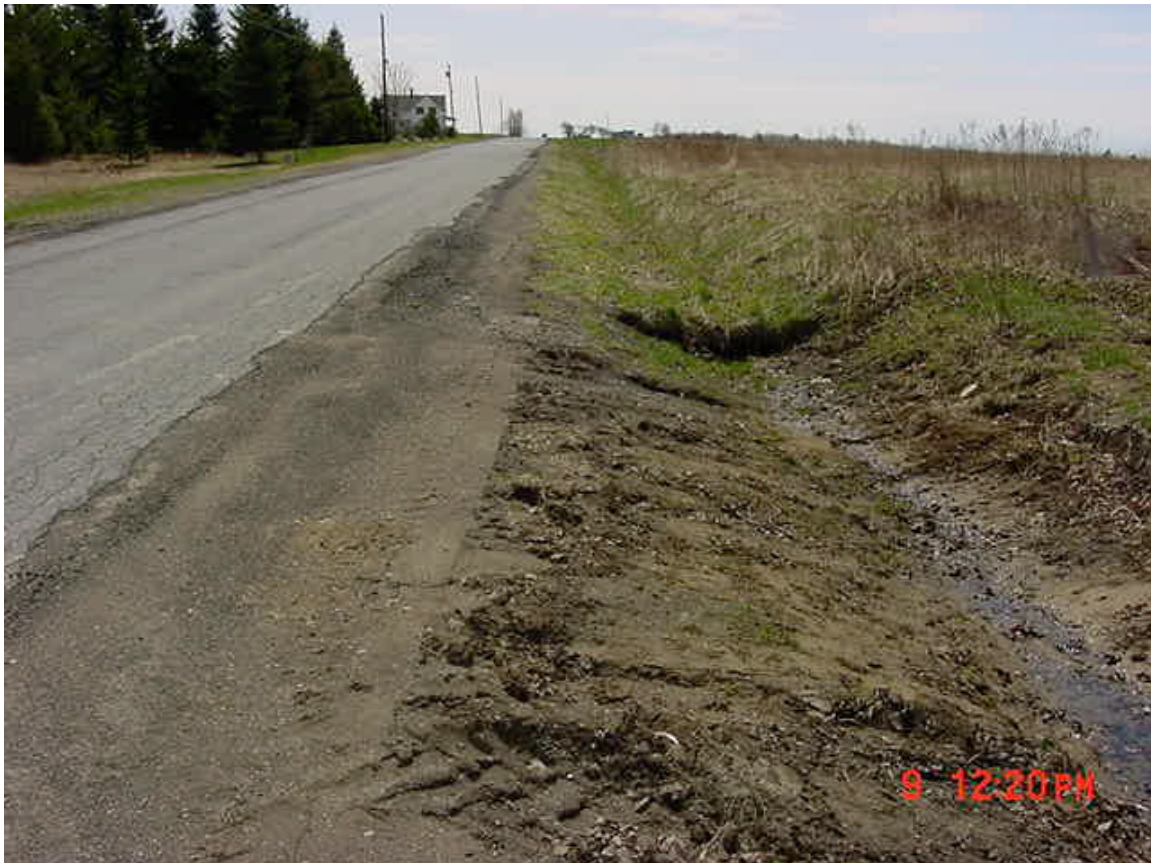
Problem: This picture portrays a number of the problems found with each of the four roads. There is slight road shoulder erosion to the ditch because the sand/salt has filled in the shoulders over the years. There is no longer an adequate grade to allow water into the vegetated ditch that has reached its capacity. Water runs along the side of the road instead, eating away at the pavement and transporting sediment to the streams and wetland that feed Trafton Lake. Where maintenance has occurred, the proper erosion control measures were not taken. Soil has been left bare for water to erode and pick up nutrients along its way to the nearest stream. Furthermore, the poor surface material making up this road is not handling the weight or size of the machinery that utilize the roads.

Solution: Increase maintenance while installing proper erosion controls, such as seed and mulch, silt fences, straw matting, erosion control blanket, rip rap, etc... Remove road sand/salt after winter so that it doesn't fill in shoulders and ditches. Grade shoulders that have been filled in to drain towards ditch. Reshape ditch keeping erosion controls in mind. Add new surface material to road.

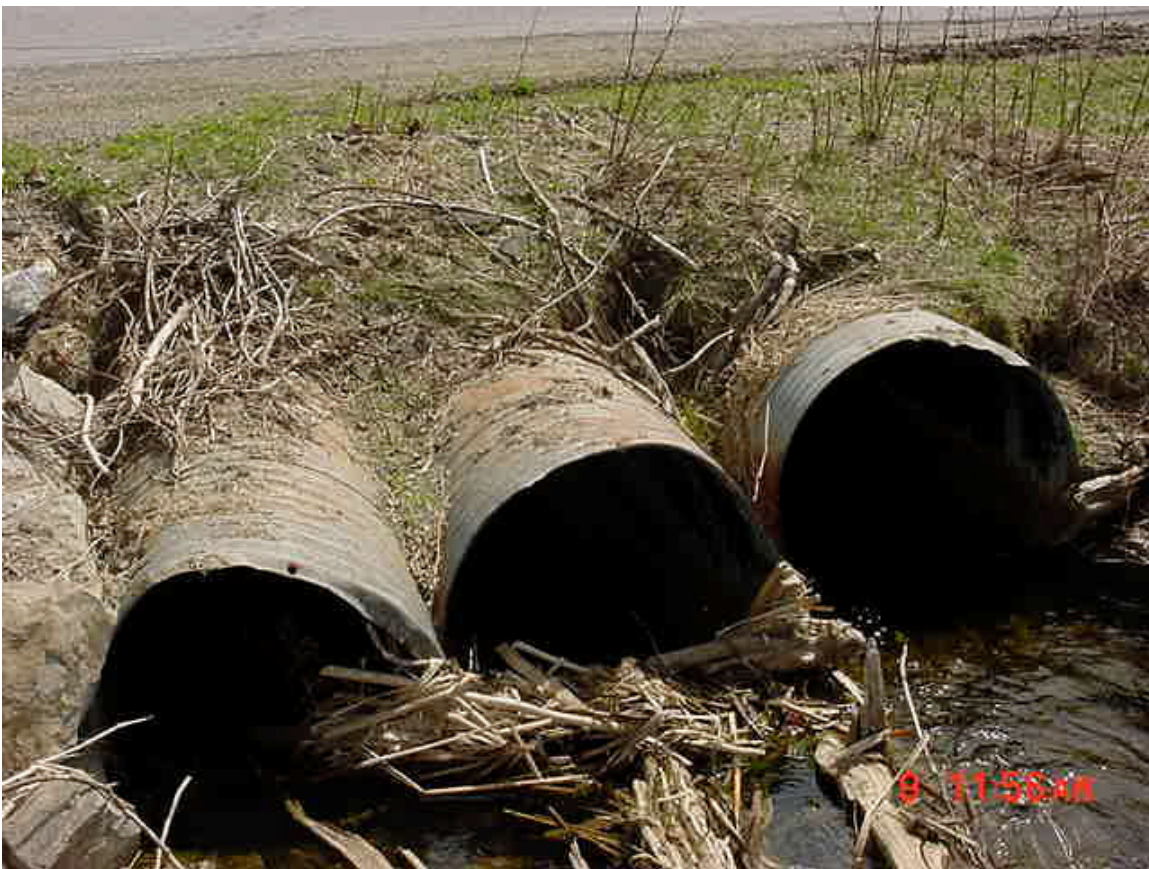
Problem: These 36" culverts lack proper armoring and maintenance. Erosion is occurring around these culverts, eating its way toward the road and carrying sediment into the pond that feeds the lake. Cleaning these culverts out isn't as much of a problem with the velocities of water rushing through, but the majority of culverts observed needed cleaned out and even replaced.

Solution: Increase maintenance of culverts, cleaning out debris and looking for problems. Armor the inlet side of these culverts with rip rap so that erosion no longer takes place. This will involve grading and installing erosion control blanket before laying rip rap around culverts.

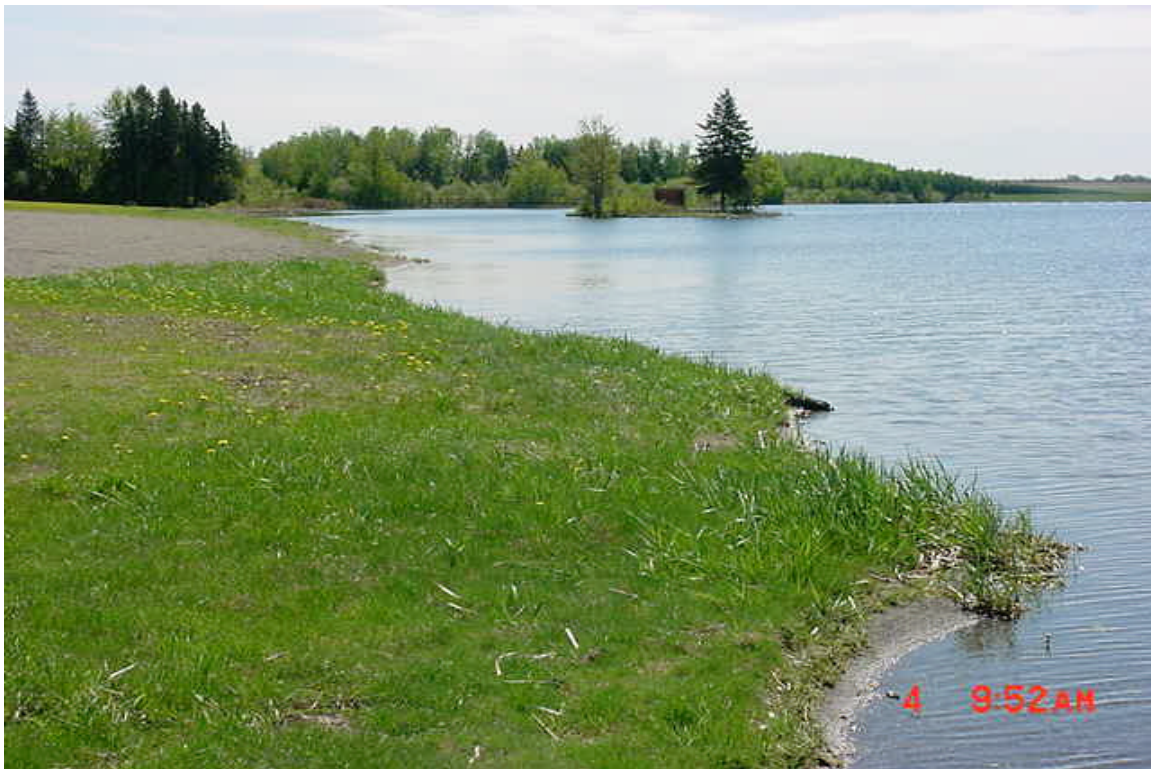
Problem: Lack of a vegetated buffer. Although the lawn does keep the soil covered in places, it does not act as a good sediment or nutrient trap; all the natural vegetation has been removed. Not only does this facilitate a high velocity of runoff, but it also disturbs the shoreline. Without roots holding the shore in place, ice and wave action has the opportunity to wash away the shore year after year.

Solution: A vegetated buffer needs to be established in order to stabilize the shoreline, as well as trap sediment and excess amounts of nutrients before reaching the lake. (Note: a soil test is recommended before fertilizing any lawn. Excess amounts of nutrients end up in the lake, not in the lawn. For more information on soil tests, contact the University of Maine Cooperative Extension office at 207-764-3361). Furthermore, a vegetated buffer deters geese from grazing lawns and leaving behind wastes that can add bacteria to Trafton Lake.

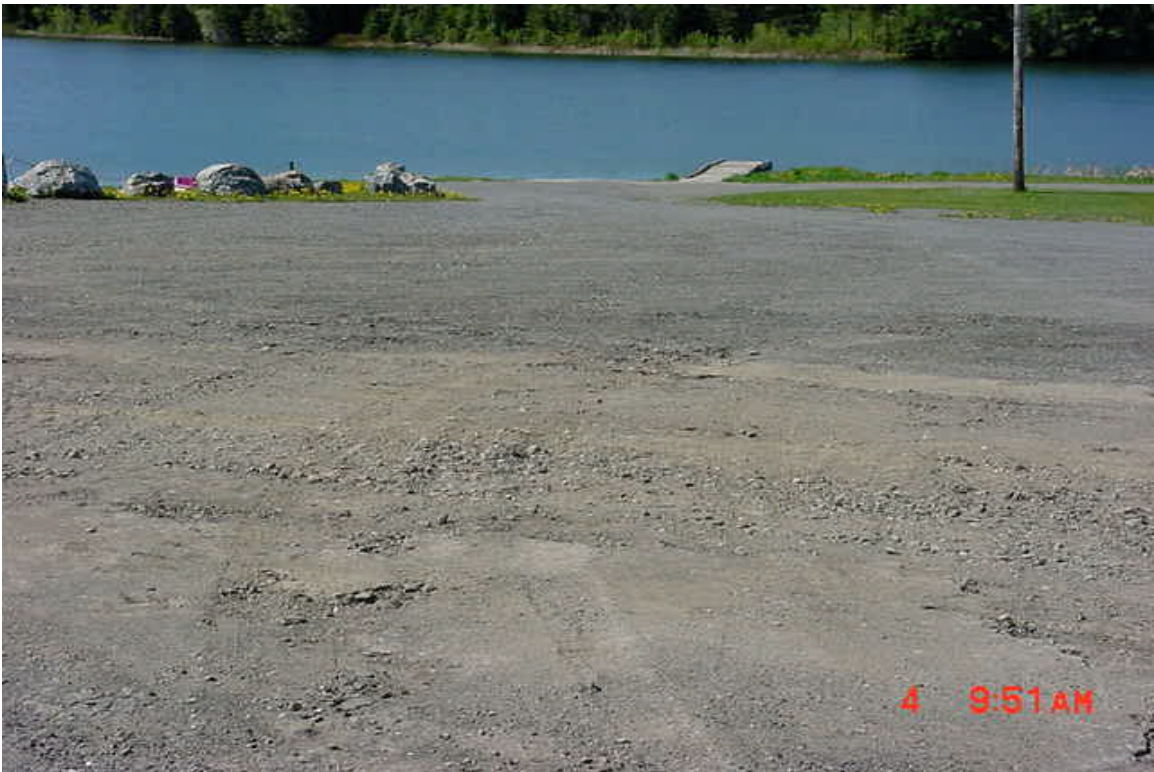
Problem: Slight-moderate surface erosion is occurring from this parking lot and running down into the lake.

Solution: Add better surface material to prevent erosion, while installing runoff diverters to intercept water and outlet it into a vegetated buffer area.
